Report Number: COELMN/PD-89/02

**EVALUATION OF THE
NATIONAL REGISTER ELIGIBILITY
OF THE VERMILION LOCK,
VERMILION PARISH, LOUISIANA**

FINAL REPORT

DECEMBER 1988

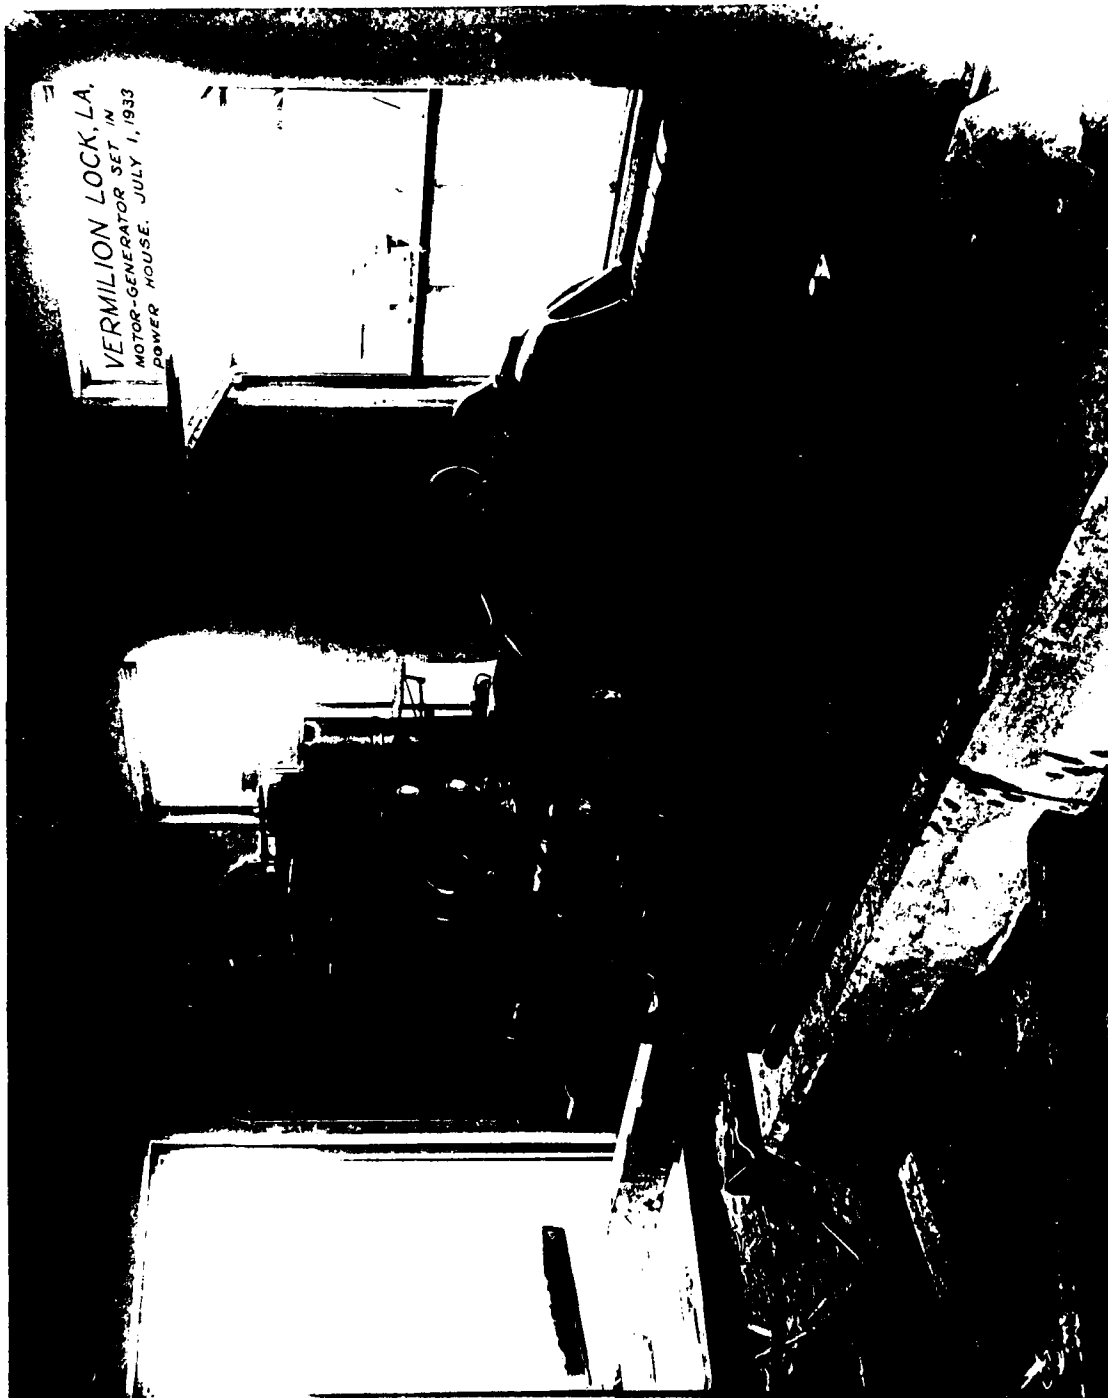
(Figure 21). The lock operator would work beside this machine. This arrangement proved to be a problem since the generator was very loud and interfered with the lock operator's task performance. Subsequently, the generator was moved into a new building on the northern bank of the lock. The structure in which it was located does not appear on original plans of the complex. This generator has been relocated to the Berwick Lock (Harold Trahan, personal communication 1988).

Figure 21. Original electrical generator in lock operator's structure (Courtesy New Orleans District, C.O.E.).

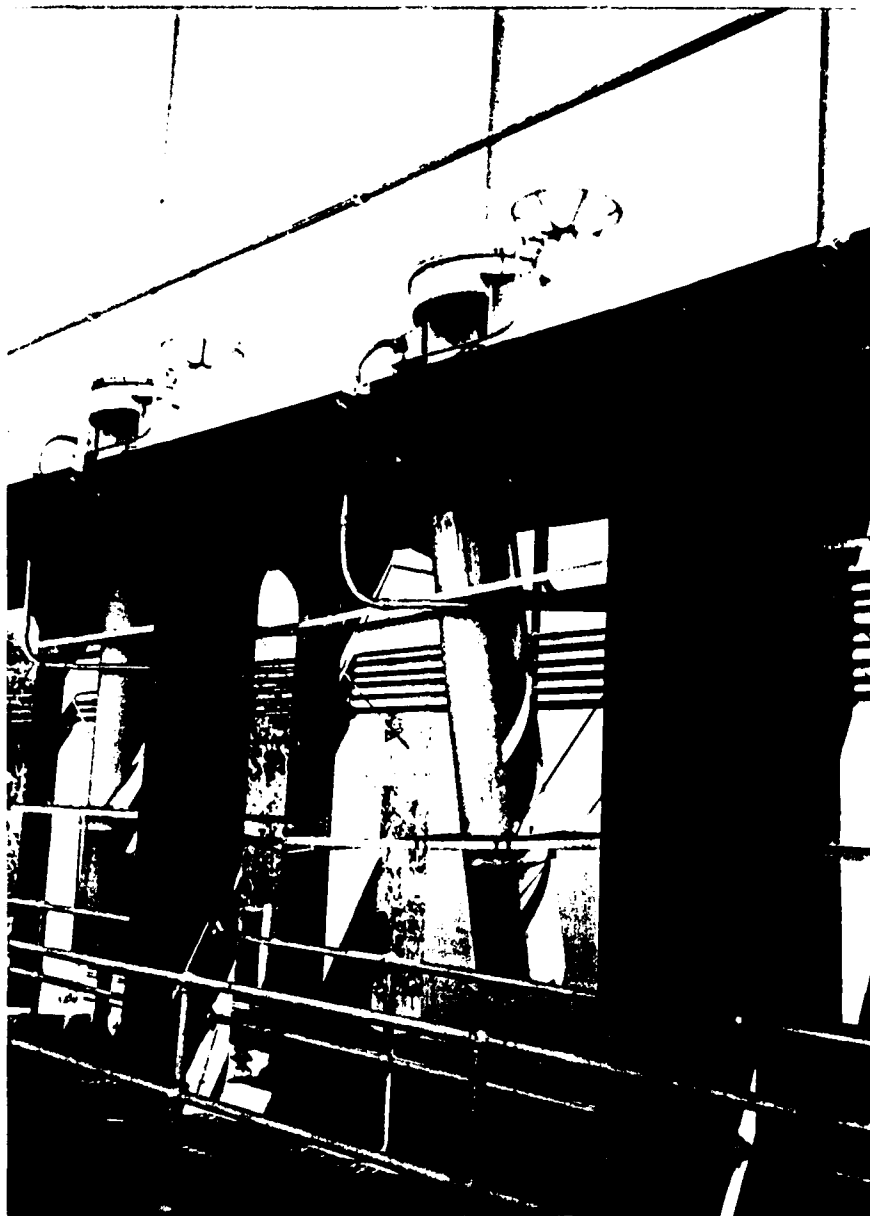
When the lock closed for operations in 1985, there were only a few sluice valves which were still in operational condition (Harold Trahan, personal communication 1988). As the lock was used, the guides became worn. A rapid current would kick the valve gate out of position. When there were fewer than ten sluice valves operating, it took longer to fill or drain the chamber. This resulted in further delays to shipping. At some point in 1976, new sluice valve gates were ordered and received on the site. These gates proved to be 8 inches narrower than the existing components. As a result, some of the sluice frames were modified by adding a Z frame to each side. The addition of these Z frames allowed the new, smaller valve gates to be used through the modification of the original assembly (Mario Slavich to Chief, Maintenance Branch, 6 August 1976).

Figure 26. Askew valve gate at Vermilion Lock.
